May 20, 2018 Payload 2 Daily Flight Report

Flight Campaign ID: 2018_P2C1

Airport, FBO ID, City: Fernando Luis Ribas Dominicci Airport (TJIG) - San Juan, Puerto Rico

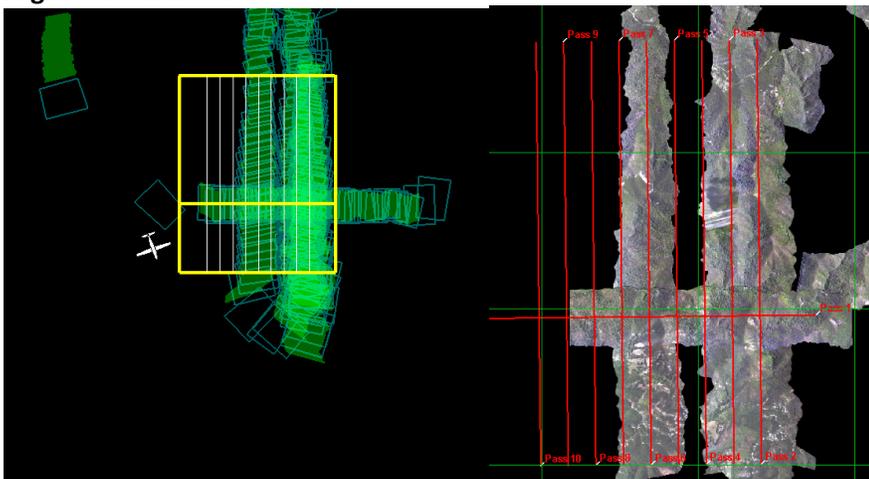
Flight Screenshots:

Concerns: Lidar display (both pilot and ASO) of plane's flight path was badly delayed, causing trouble lining up on the flight line. See below. The camera had intermittent automatic turn-on, so manual triggering was required at the beginning of lines.
